GRANGEBEL PARK HISTORY

2009 Spillway Work

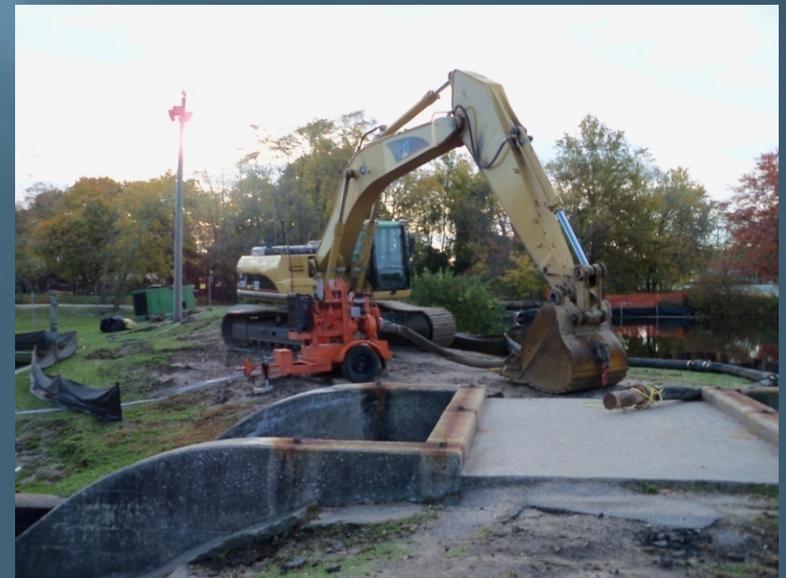
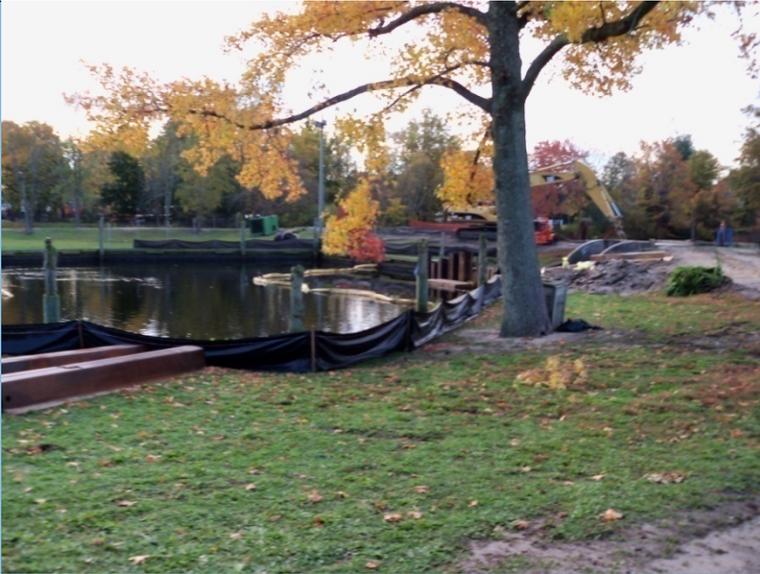
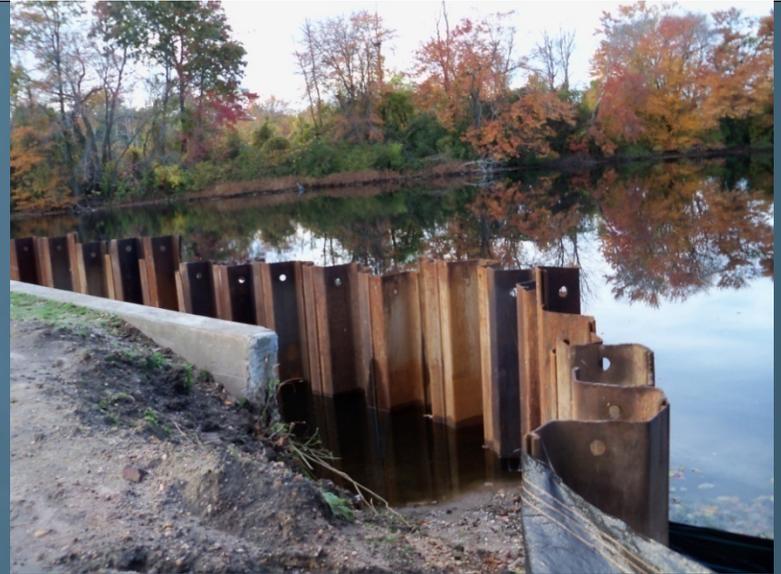
The north spillway repairs required that the contractor de-water the site prior to work. The estimated original construction dated back to the late 1800's. The spillway was in excellent condition, however the abutment walls, wing walls and overhead wall had experienced significant concrete spauling over the years that required massive repairs.

North Spillway repair work had to be performed before the Fish Passage could be constructed at the location of the former South Spillway. This was staged so that when the water was bypassed to the north spillway during the fish passage construction the north spillway would be able to accommodate the additional flows. The Contractor, Terry Contracting had to access from the south side of the park. Work began for the repairs to the north spillway in October 2009

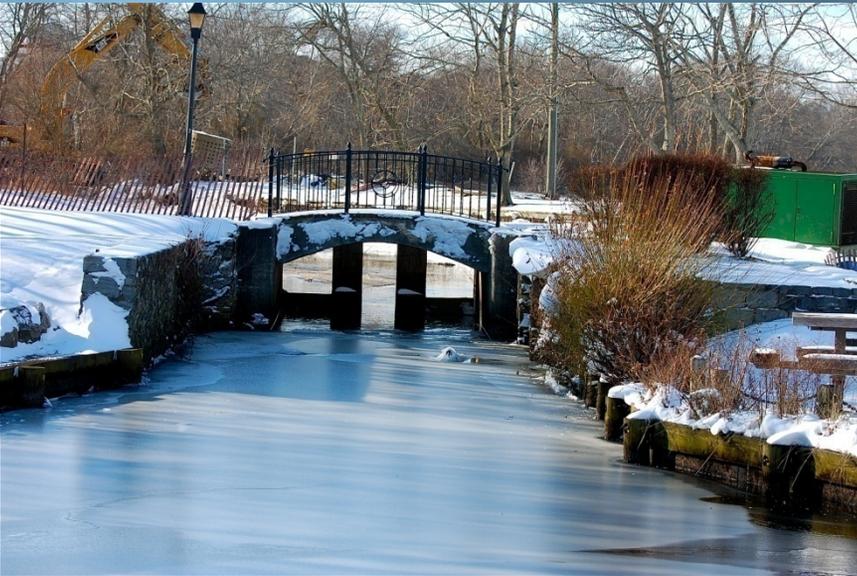
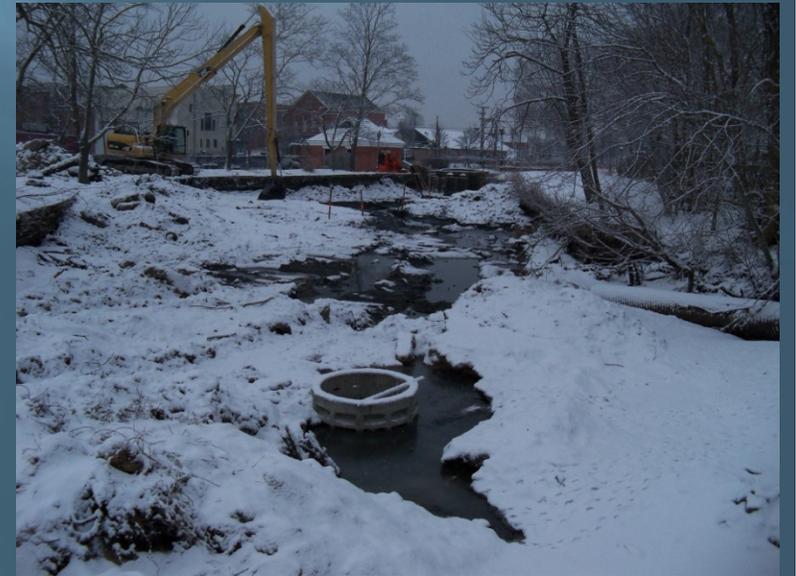
The South Spillway was dewatered in January 2010, following completion of the North Spillway rehabilitation, the soils upstream of the spillway were found to be in poor condition. When they tried to put the base stone in, it would disappear in the muck

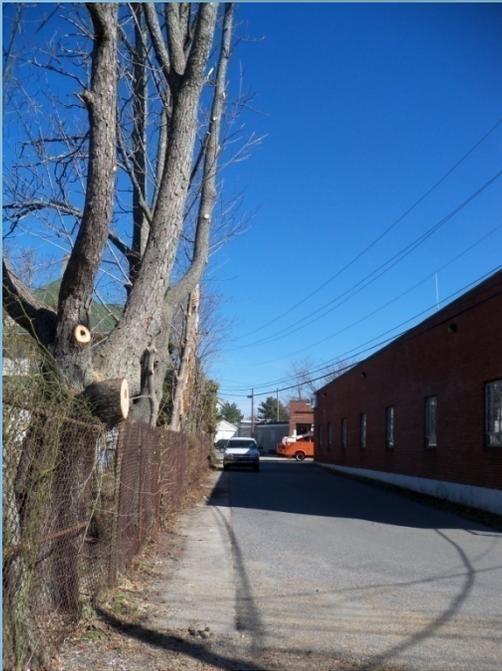
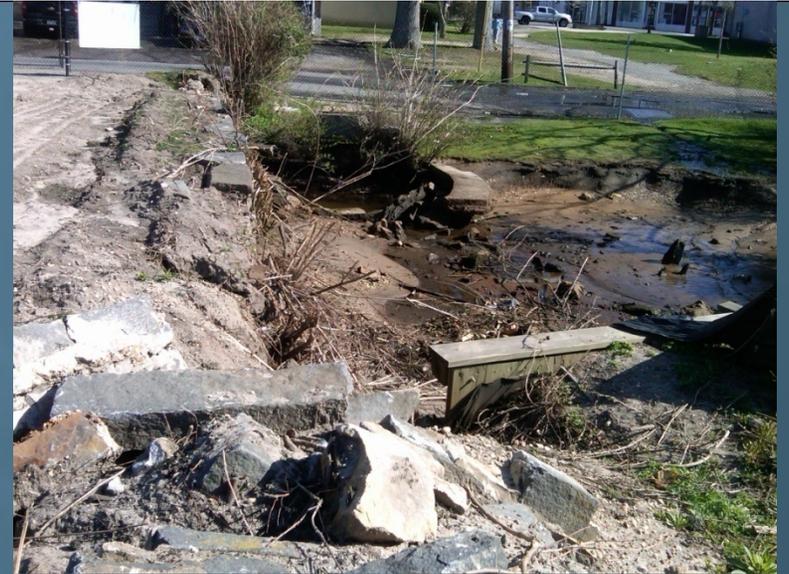
The Town received Bids in January 2010 for the site improvements to the park...the last stage. Work rolled from the spillway work into the site work which re-routed electrical utilities to remove the guy wire going to the center island and provide more power to the site

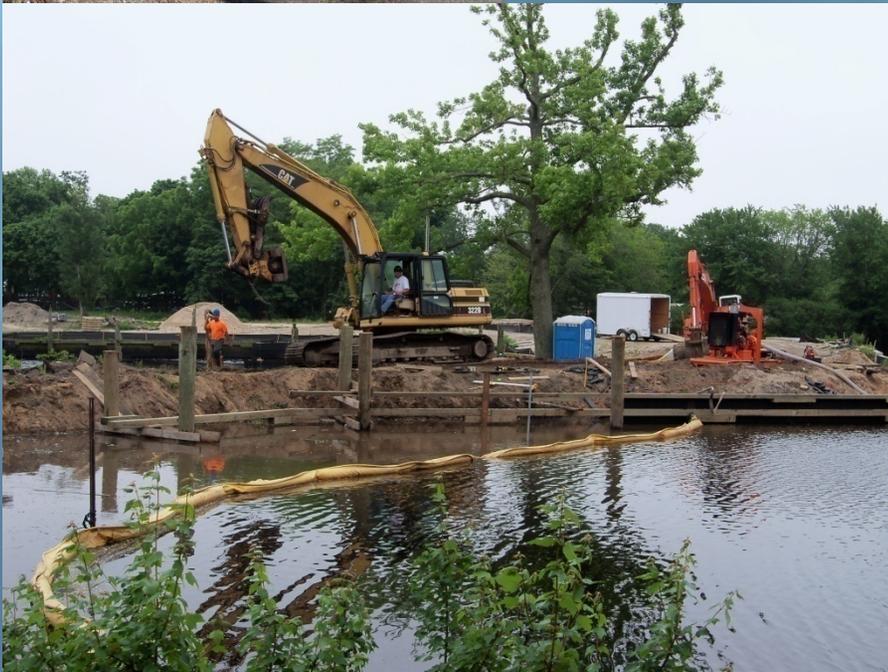
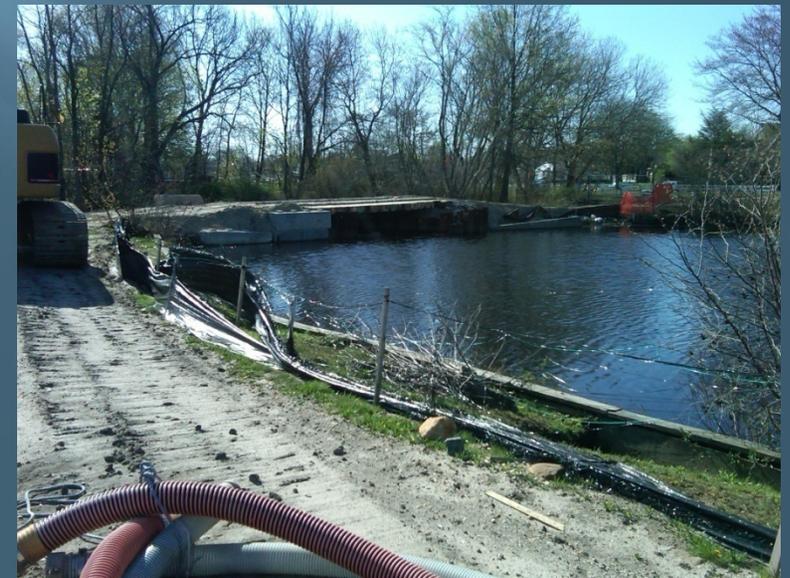
Work to replace bulkheading, restore Bridal Veil Falls, site lighting, pathways and the bridge to the Suffolk County Property were all part of the project

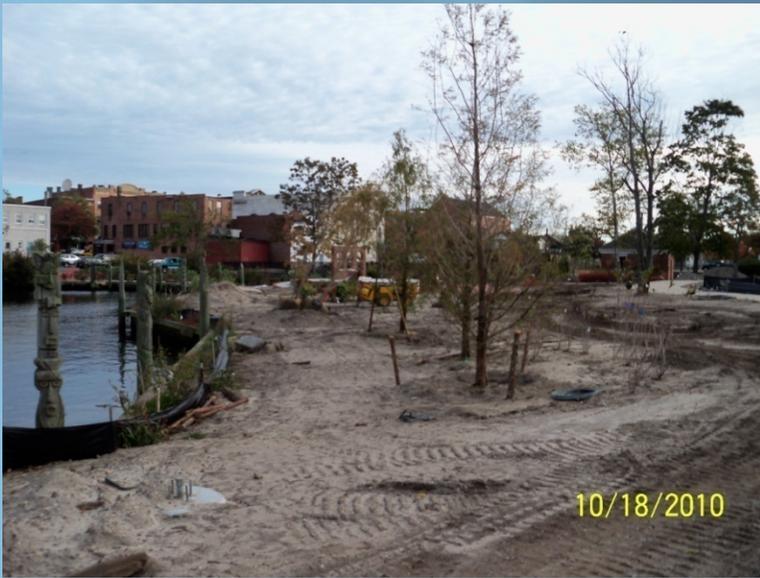
Bridal Veil Falls was re-constructed to include a stormwater control to contain upstream trash from entering the downstream pond. The landscaping will restore Grangebél Park to the turn of the century park which show cased beautiful landscaping to create a peaceful escape from a busy work day
